Re: Results of Hecla and OMG Site Visit  
of May 16 -17, 2005

**SUBJECT:** Technical Memorandum for the Site Visit to the Hecla Impoundment (Pond #2) and Inspection of the Supplemental Environmental Project at the OMG Facility, St. George, Utah

**FROM:** Randall W. Breeden, Geohydrologist  
RCRA Corrective Action Technical Support

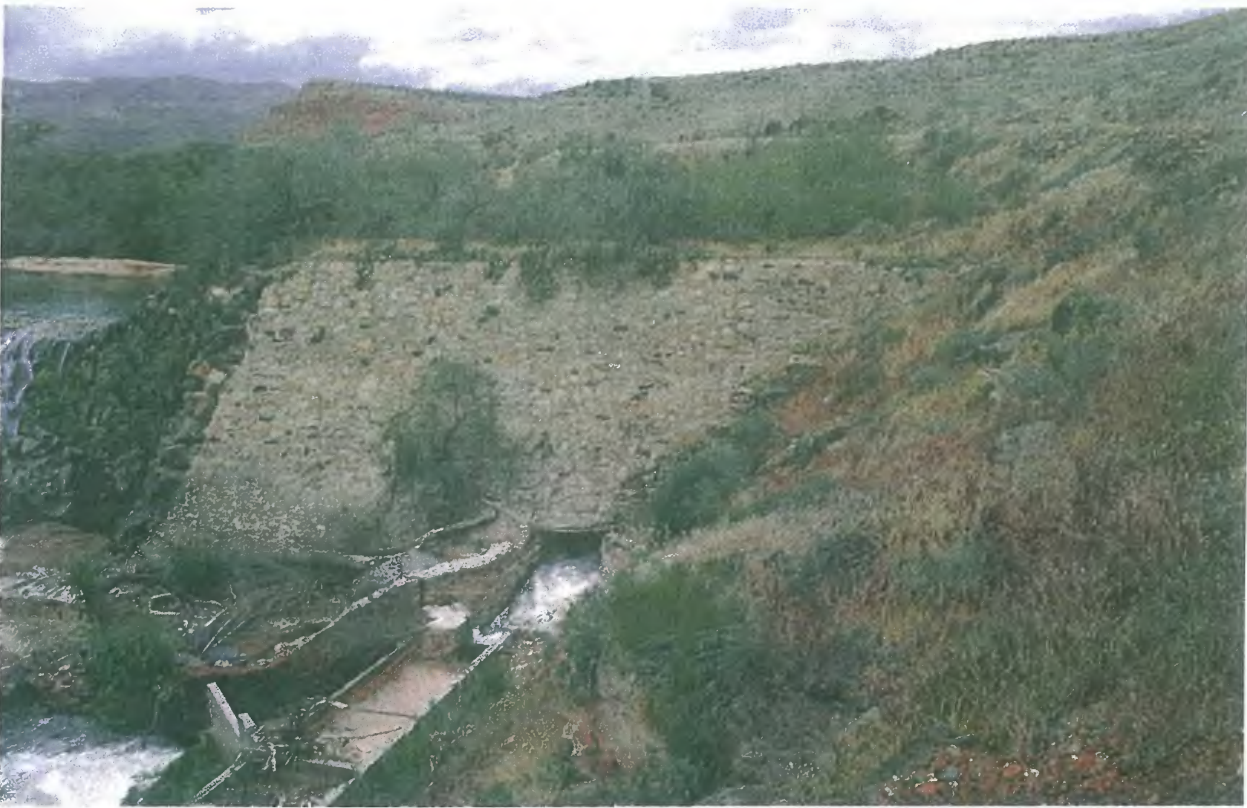
Picture 45. Diversion Headgate (where it normally enter the pipeline, however there are not gates).
